Dealer Service Instructions for:

Customer Satisfaction Notification No. C42 Powertrain Control Module Connectors

2003 (DR) Dodge Ram Pick-up Truck

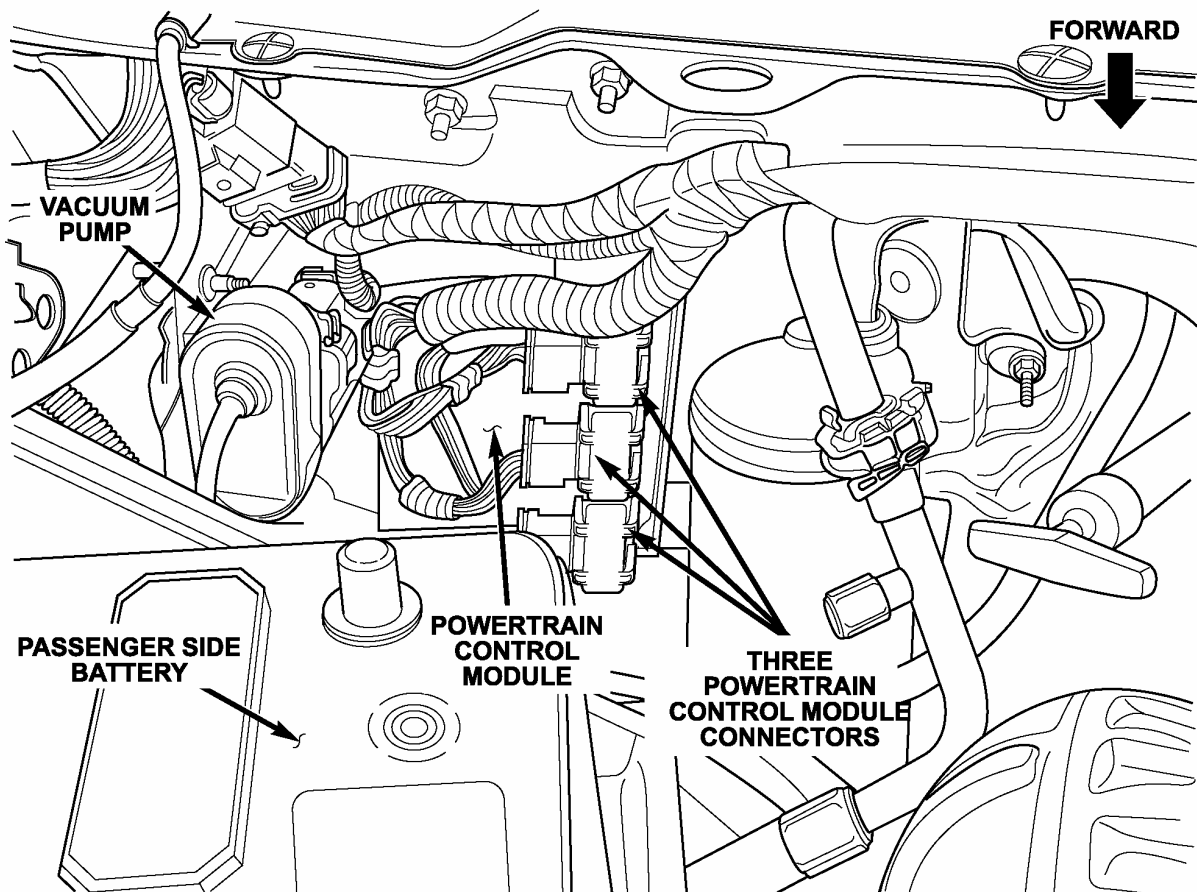
Figure 1

The Powertrain Control Module (PCM) electrical connectors on about 70,000 of the above trucks may allow water to enter into the connectors. Water and the resulting corrosion in a PCM connector can cause the speed control and/or transmission overdrive function to become inoperative.

1. Open the hood.
2. Disconnect both negative battery cables.
3. Disconnect the three (3) harness connectors from the PCM (Figure 1).
4. Inspect the connectors and PCM for the presence of corrosion.
 - If **no corrosion** is found in the PCM connector and/or on the PCM pins continue with Section “B. Install Harness Connector O-rings.”
 - If **corrosion** is found in the PCM harness connector and/or on the PCM pins continue with Section “C. Replace the PCM and Transmission Wiring Harness.”
